EMERGENCY TELEPHONE SERVICE – CIVIC EXCHANGE, CANBERRA

*J. WHYBOURNE, A.M.I.E.Aust.**

INTRODUCTION

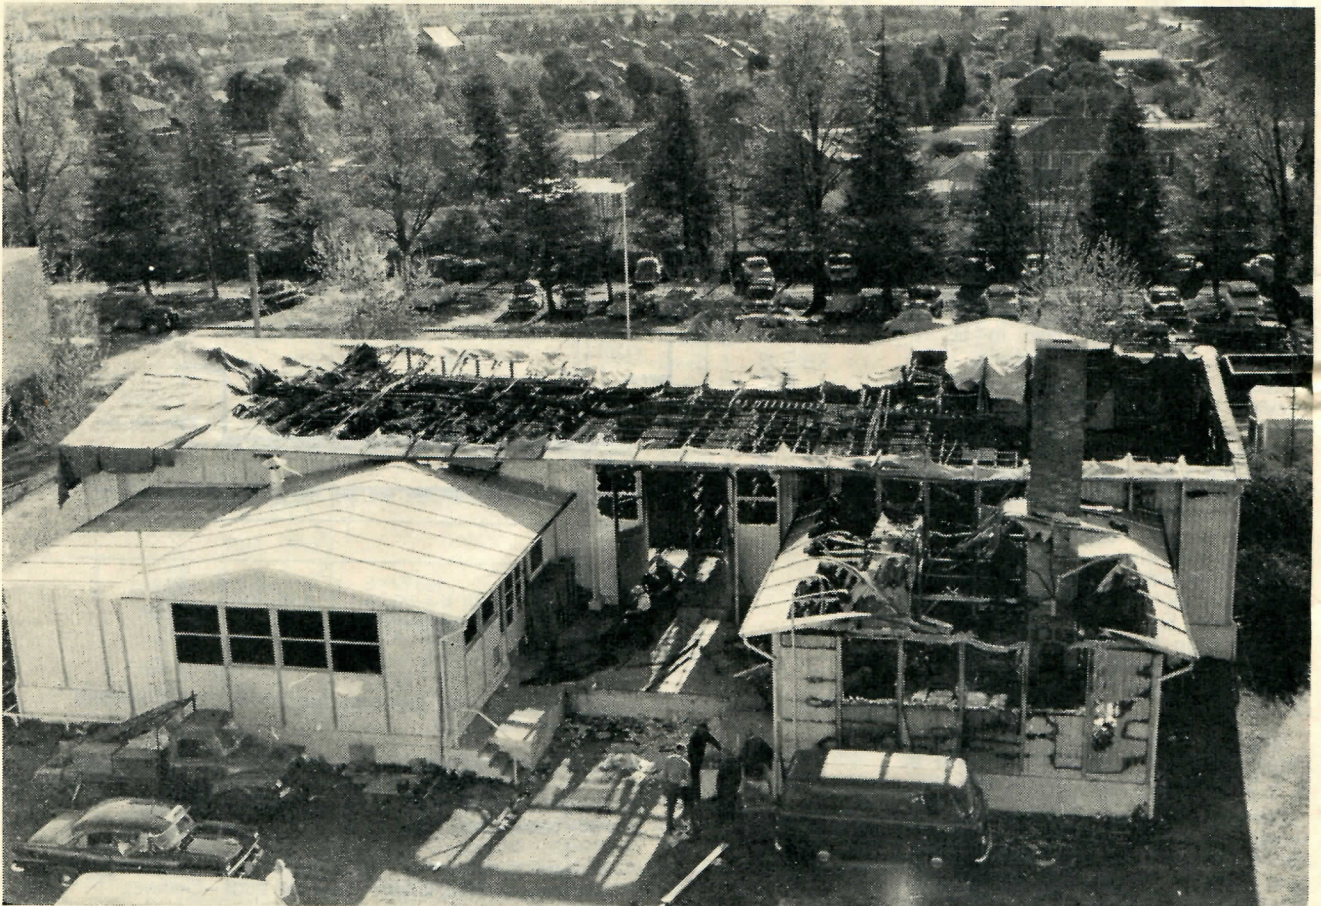
Fig. 1.—Looking down on Damaged Building, showing Destruction of Air Treatment and Equipment Areas.

At approximately 1 a.m. on Friday 22nd September, 1961, a fire which originated in the air treatment wing of the pre-fabricated aluminium telephone exchange building at Civic, resulted in the complete destruction of a 2,000 type exchange, with 5,482 working lines and a capital value exceeding £500,000. It served the main Canberra commercial centre at Civic as well as the hospital, police and fire brigade, in effect over one-third of the Canberra network. The cause of the fire was not apparent, but it was determined later that it had been started deliberately by vandals. Figs. 1 and 2 illustrate the damage.

Examination immediately after the fire was extinguished revealed that the switching installation was completely destroyed. Considerable portions of most racks were seriously damaged by fire and almost all equipment was saturated by water and covered with a sticky deposit. The upper part of the M.D.F. was badly damaged and lead-covered silk-insulated subscriber and junction cable tails were burnt through. The roof over almost the entire length of the 100 x 40 ft. equipment/M.D.F. room had disappeared. It was apparent that, as the walls were seriously damaged and structurally unsound, rehabilitation of the building would virtually require a completely new equipment room. The power and battery room installation was almost undamaged and the test desk, together with the power and test desk rooms, had suffered minor damage only. The M.D.F. and cable record cards were recovered intact, which was of considerable significance in the light of subsequent events.

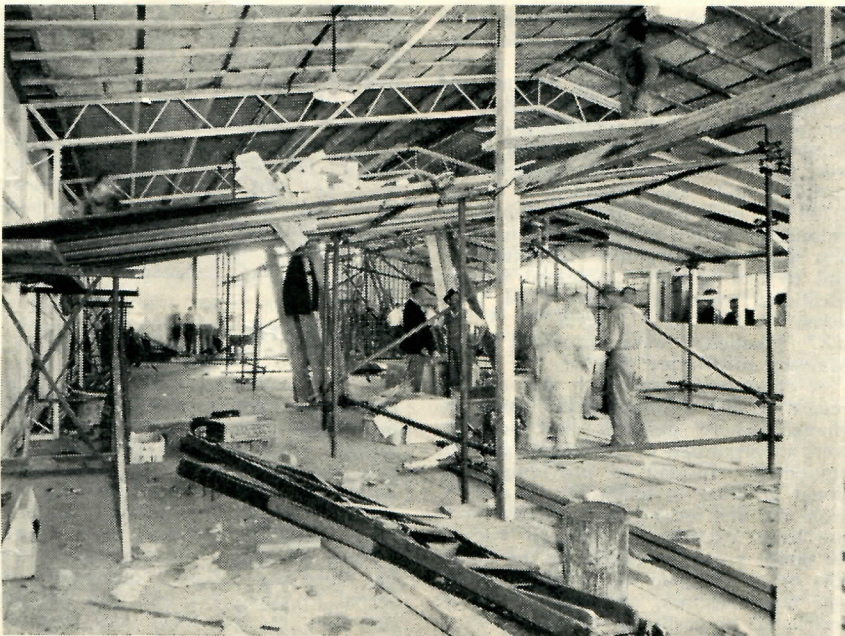
Fig. 6.—Scene inside the Line Depot Building on the Day of the Fire. New M.D.F. is being Erected and Roof Insulation is in Progress.
